# **Debris/Ice/TPS Assessment and Integrated Photographic Analysis for Shuttle Mission STS-54**

**March 1993**

DEBRIS/ICE/TPS ASSESSMENT  
AND  
PHOTOGRAPHIC ANALYSIS  
OF  
SHUTTLE MISSION STS-54

January 13, 1993

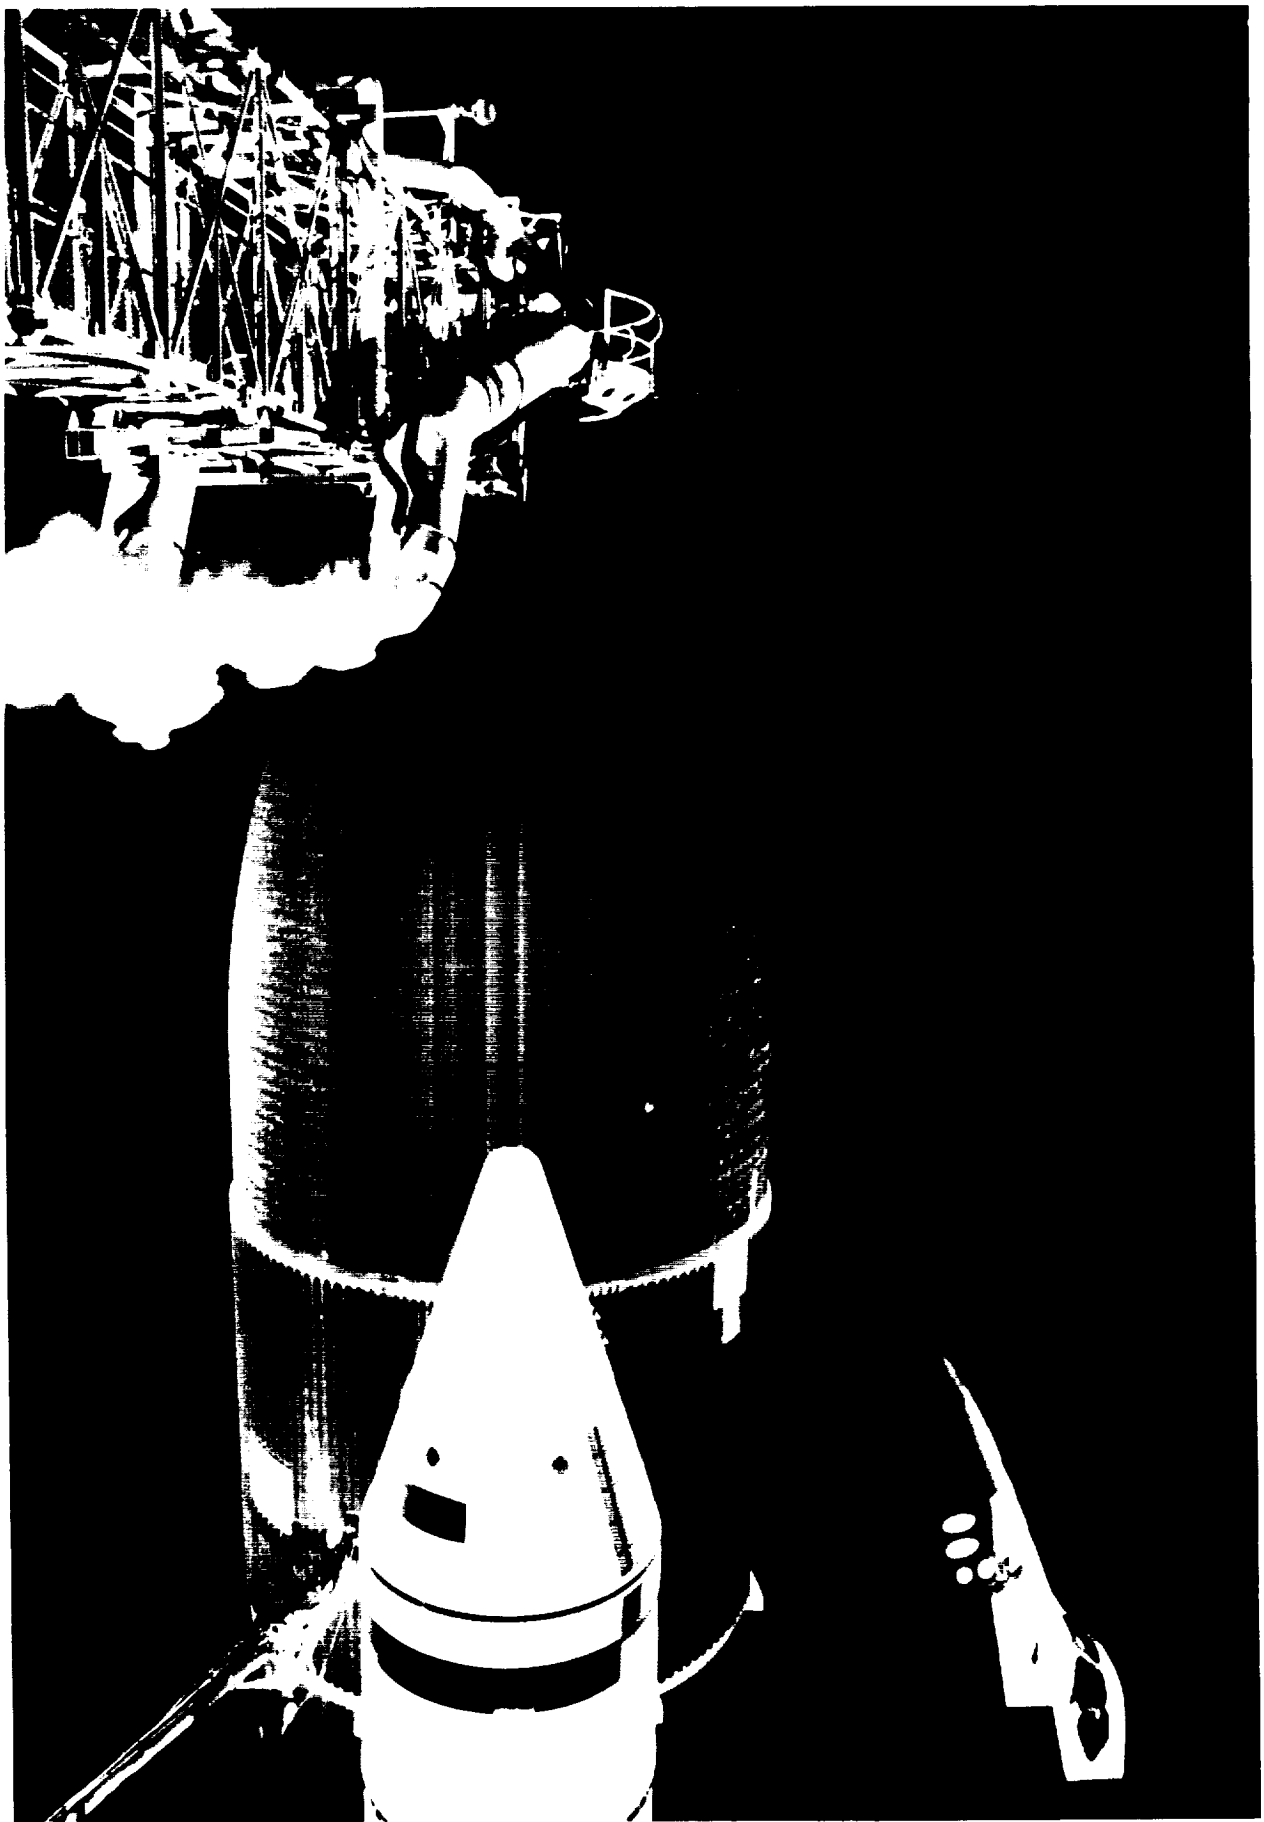
There were no TPS anomalies or ice/frost accumulations on the LO2 tank. Some light condensate was present on the LO2 tank barrel section.

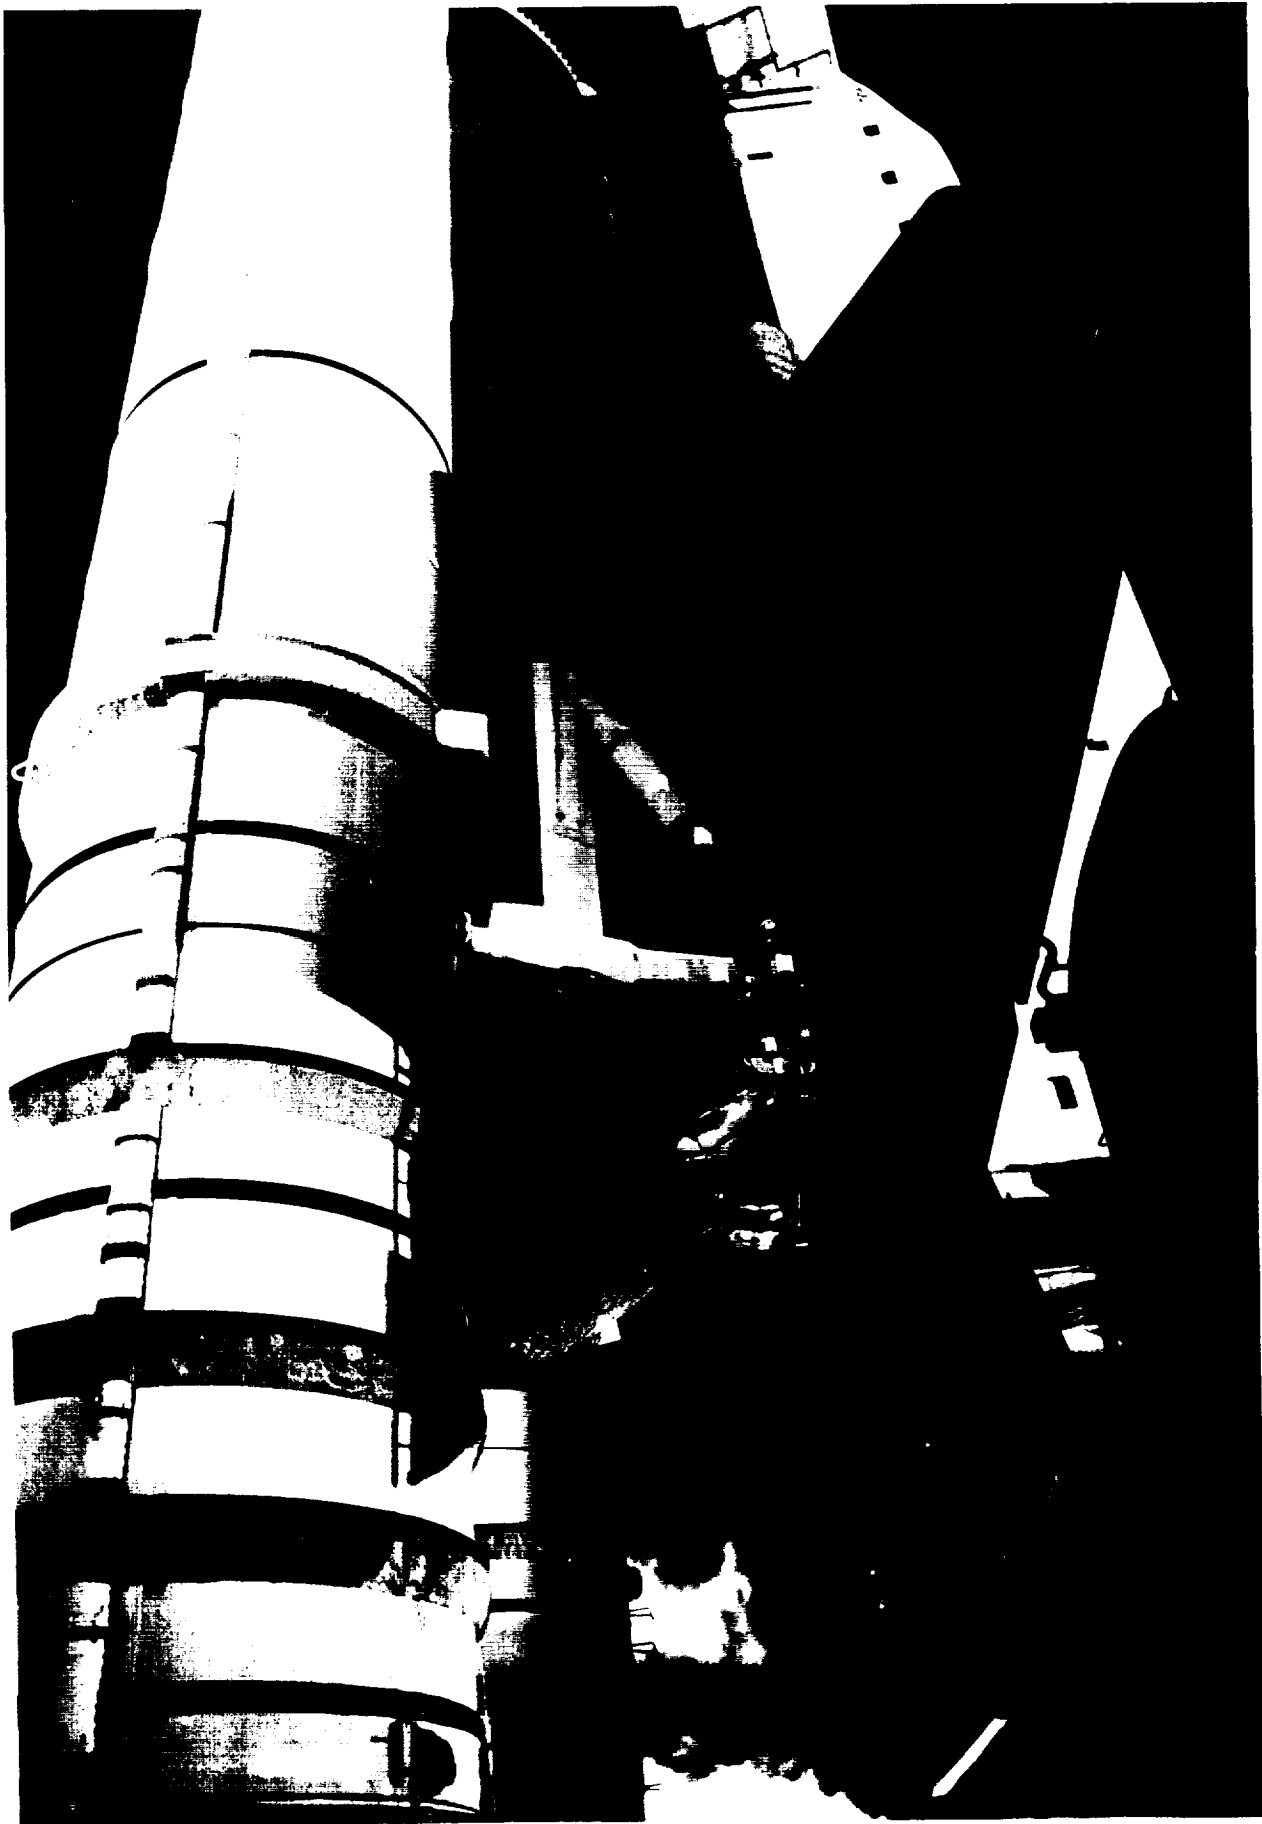
There were no LH2 tank TPS acreage anomalies. Light condensate, but no ice or frost, was present on the acreage and aft dome.

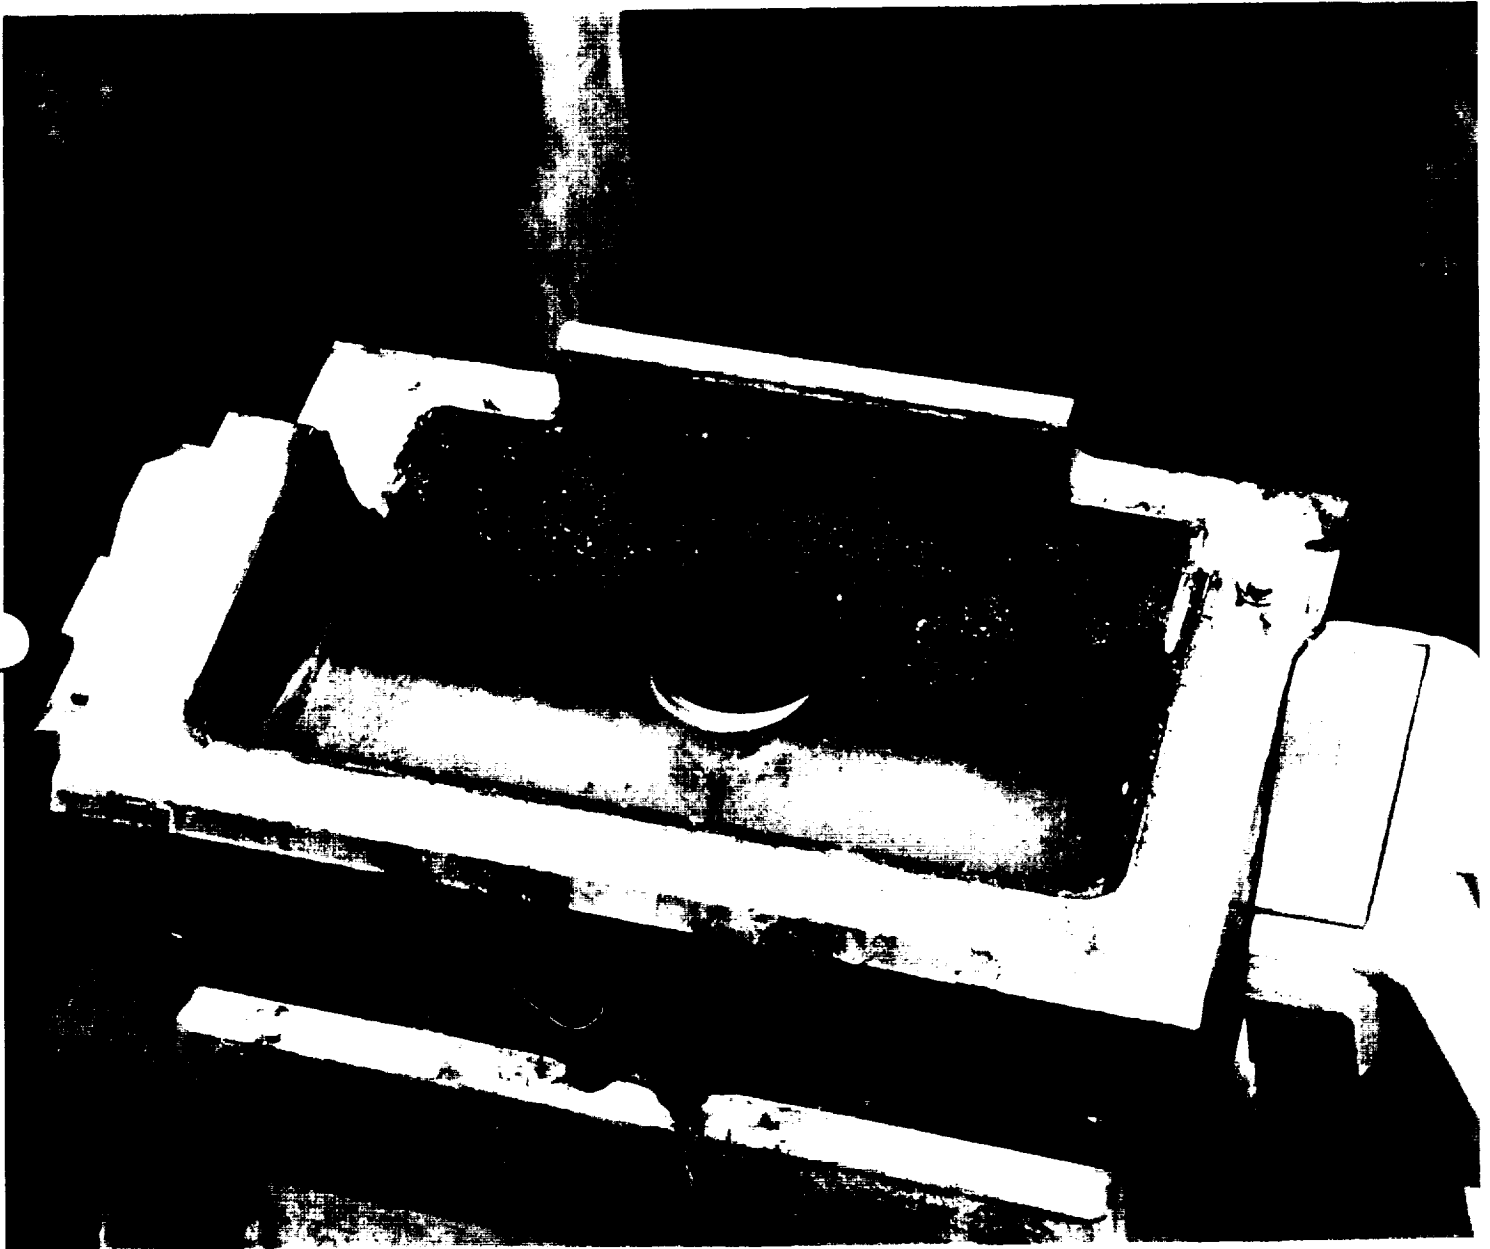
Plume erosion of the south SRB holddown posts was typical. EPON shim material was intact but slightly debonded from the sidewalls of the holddown post shoes.

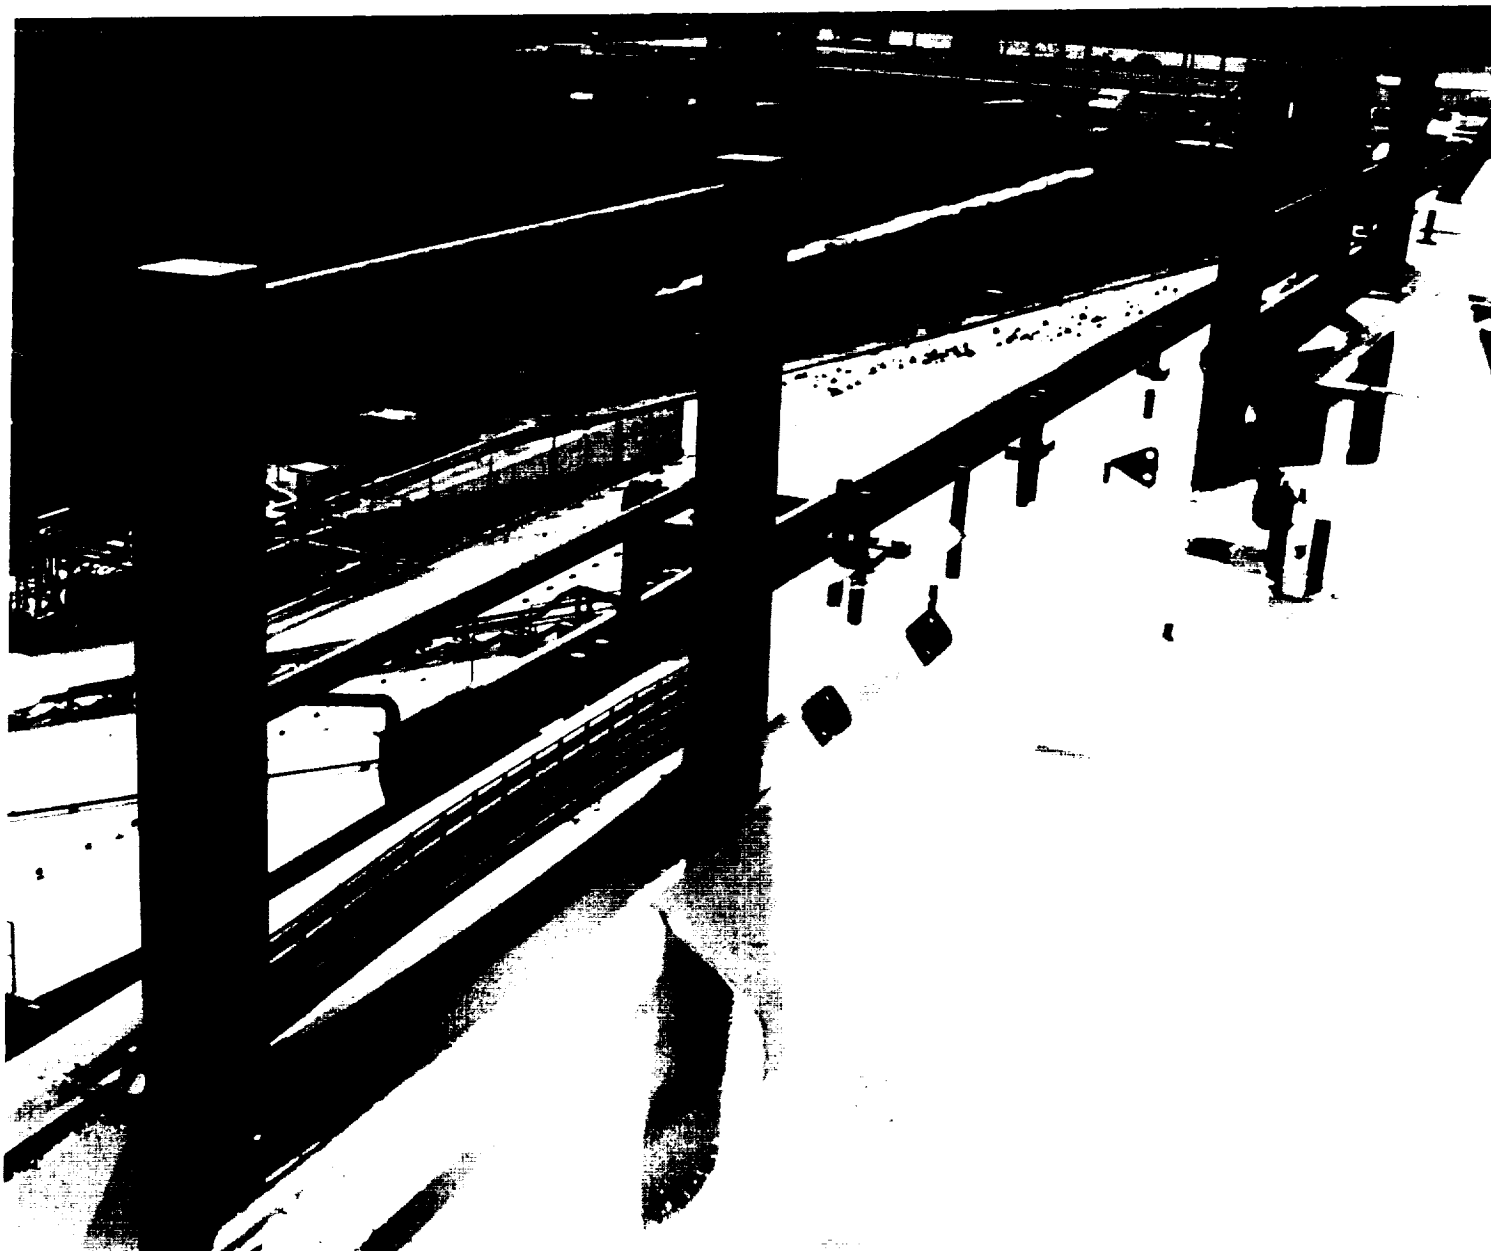
The seven test sections of the permanent MLP deck perimeter handrails were generally in good shape after launch except for the east and west side removable sections, which exhibited minor deformation of the kickplates.

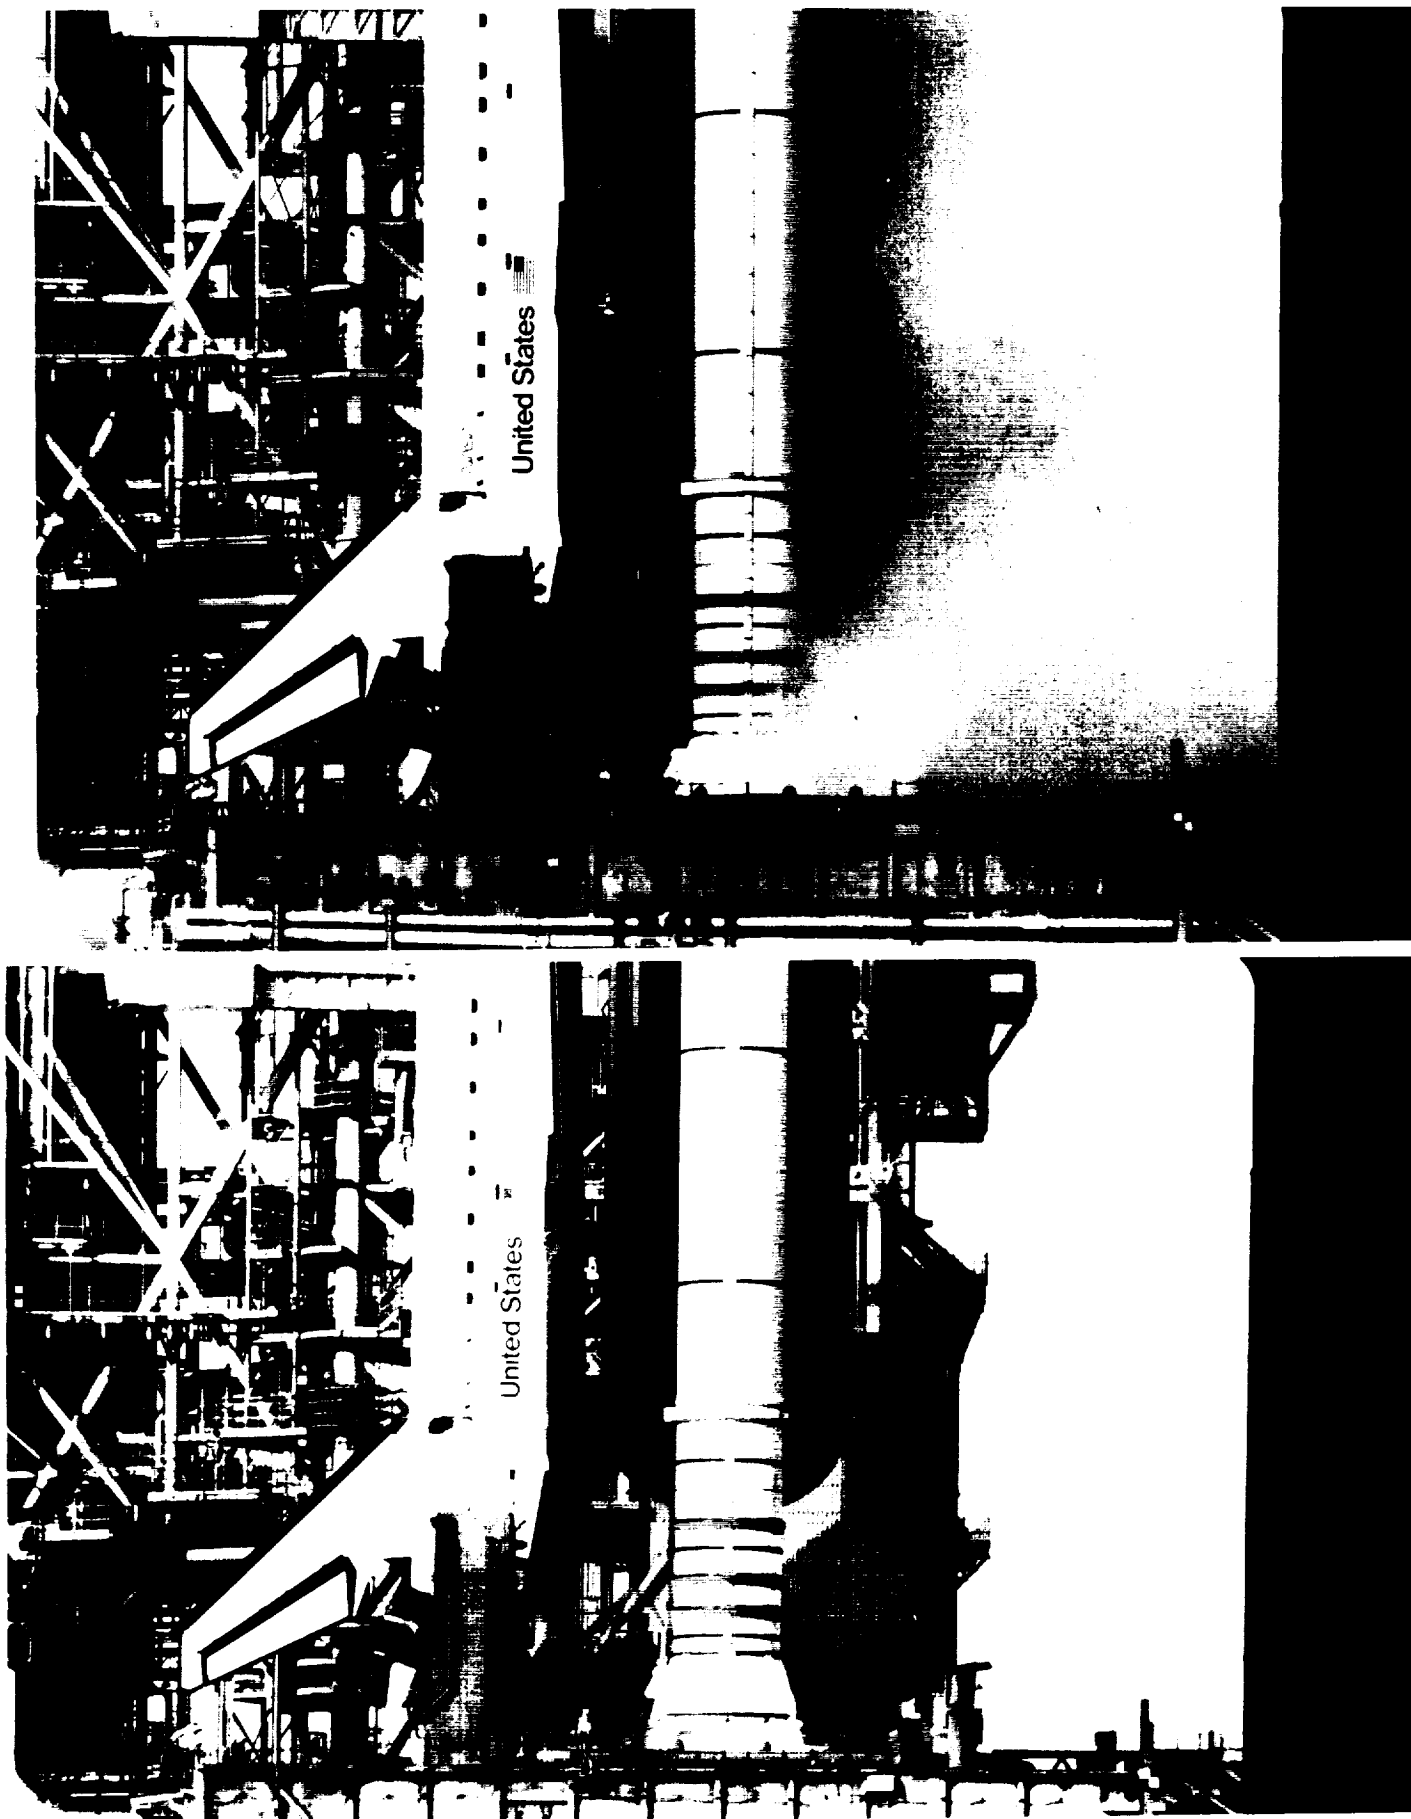
Shock wave from the SRB plume caused the momentary formation of a vapor cloud by condensing water vapor out of the atmosphere. This phenomenon, though not usually so visible, is an expected occurrence.

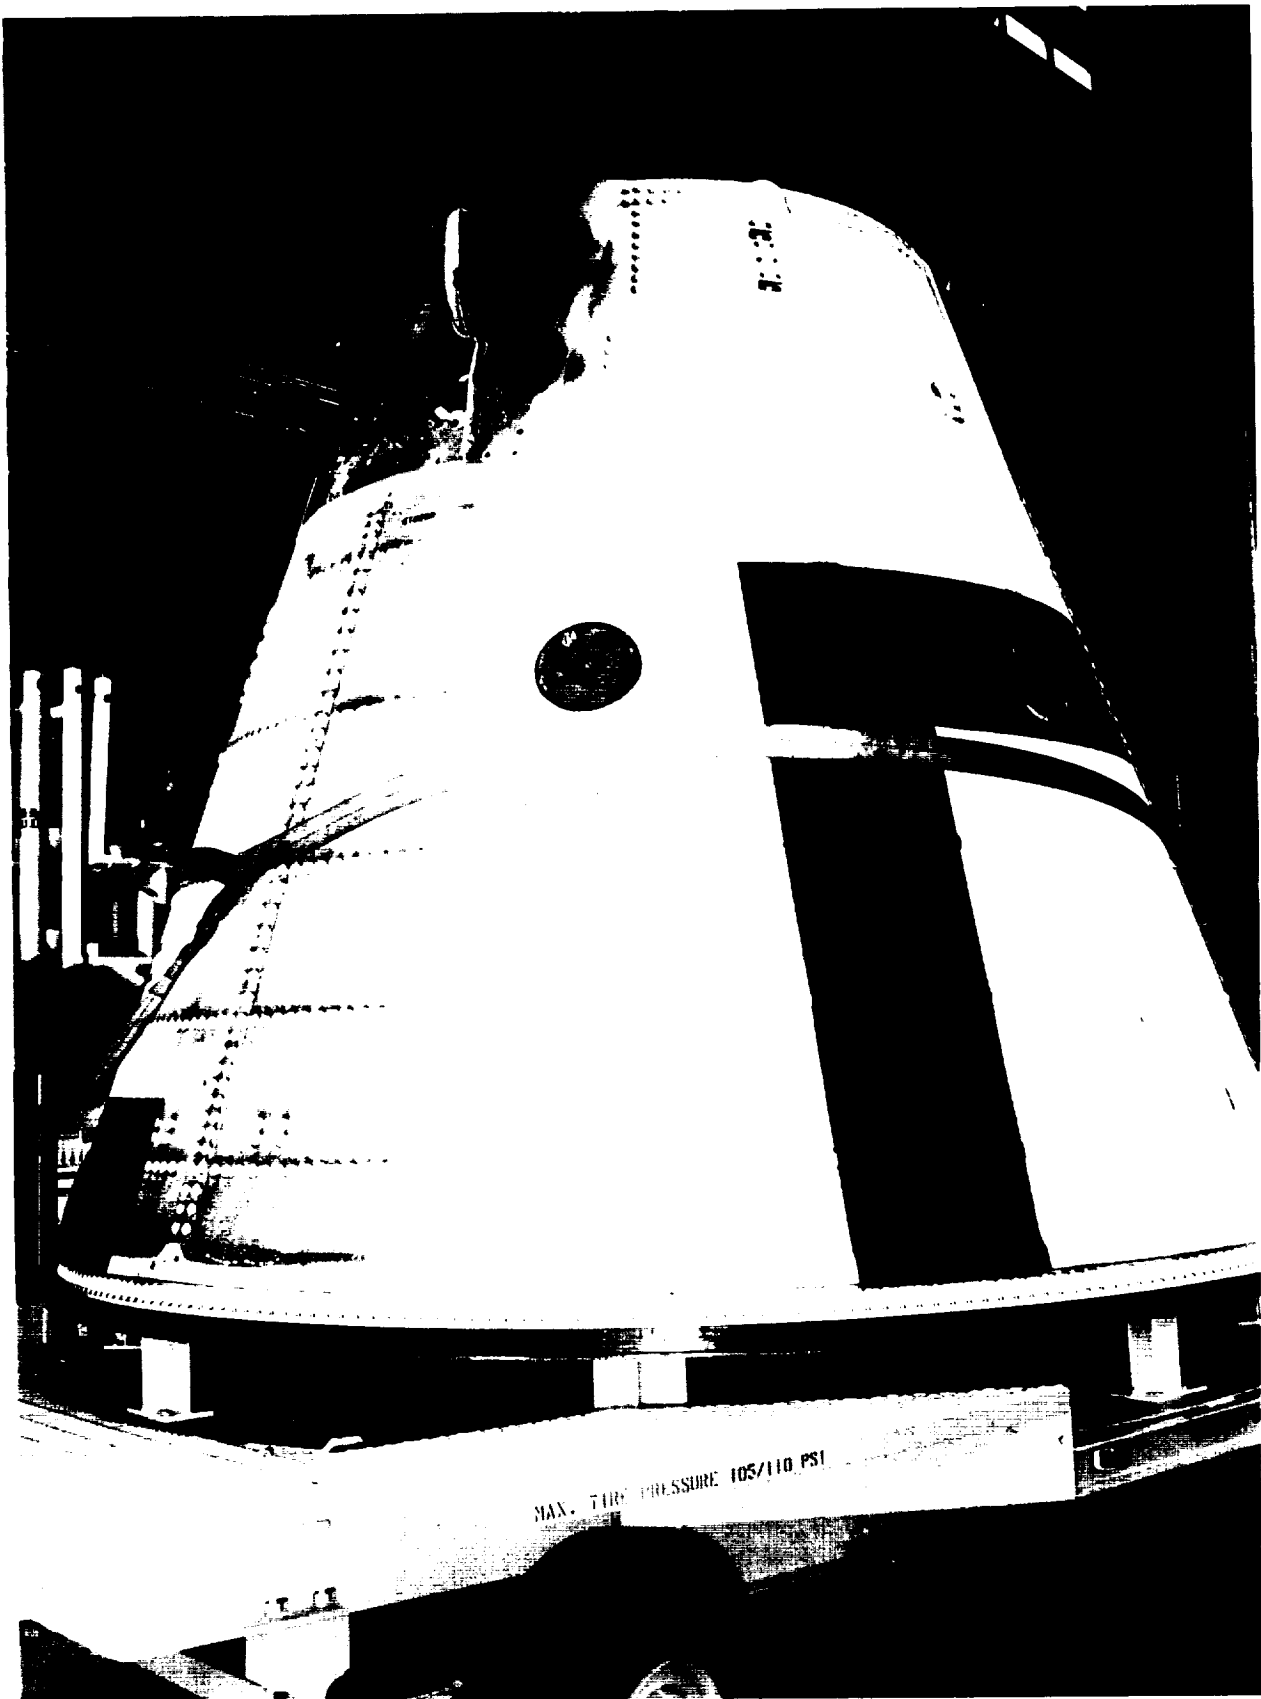
The RH frustum was missing no TPS, but had 31 MSA-2 debonds over fasteners. All BSM aero heat shield covers were locked in the fully opened position though the lower left cover attach ring had been bent by parachute riser entanglement.

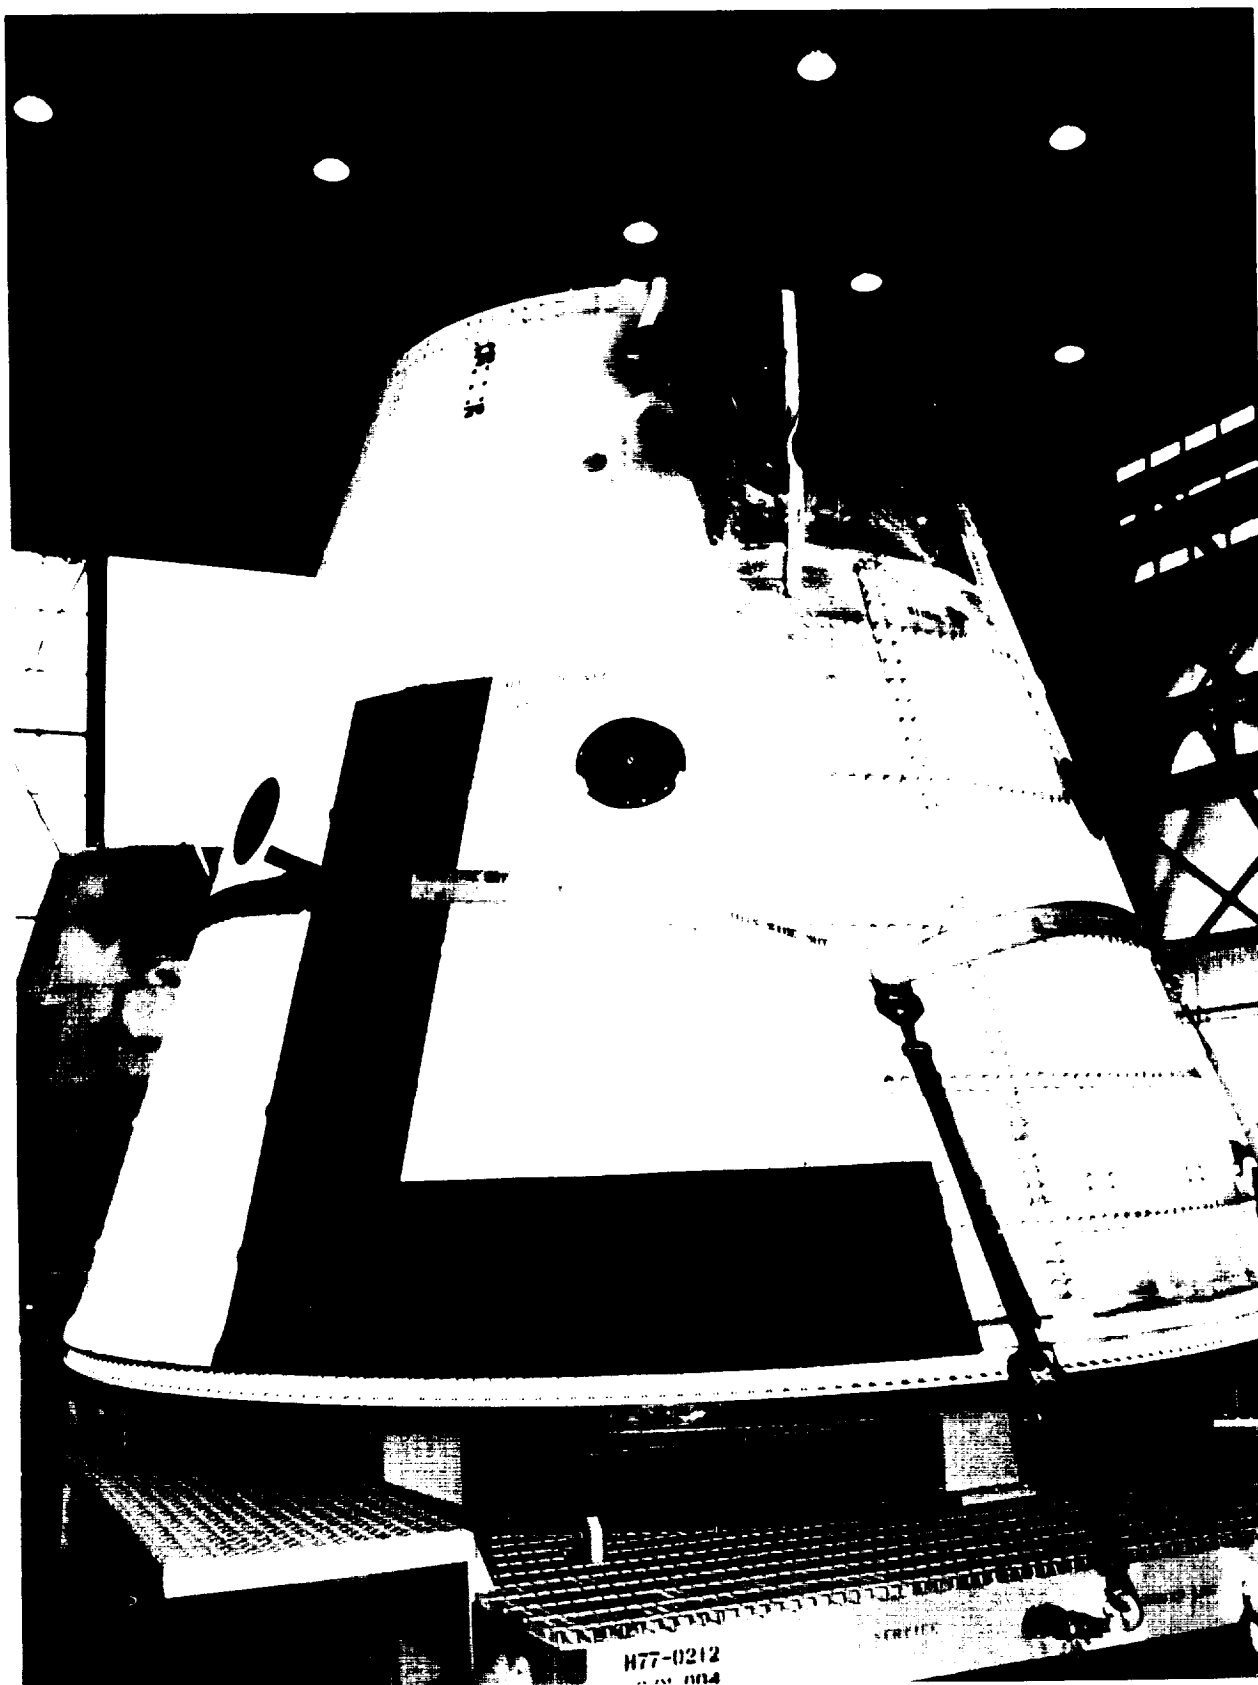
The LH frustum was missing no TPS, but had 18 MSA-2 debonds over fasteners. The BSM aero heat shield covers were locked in the fully opened position, though the lower left cover attach ring had been bent by parachute riser entanglement.

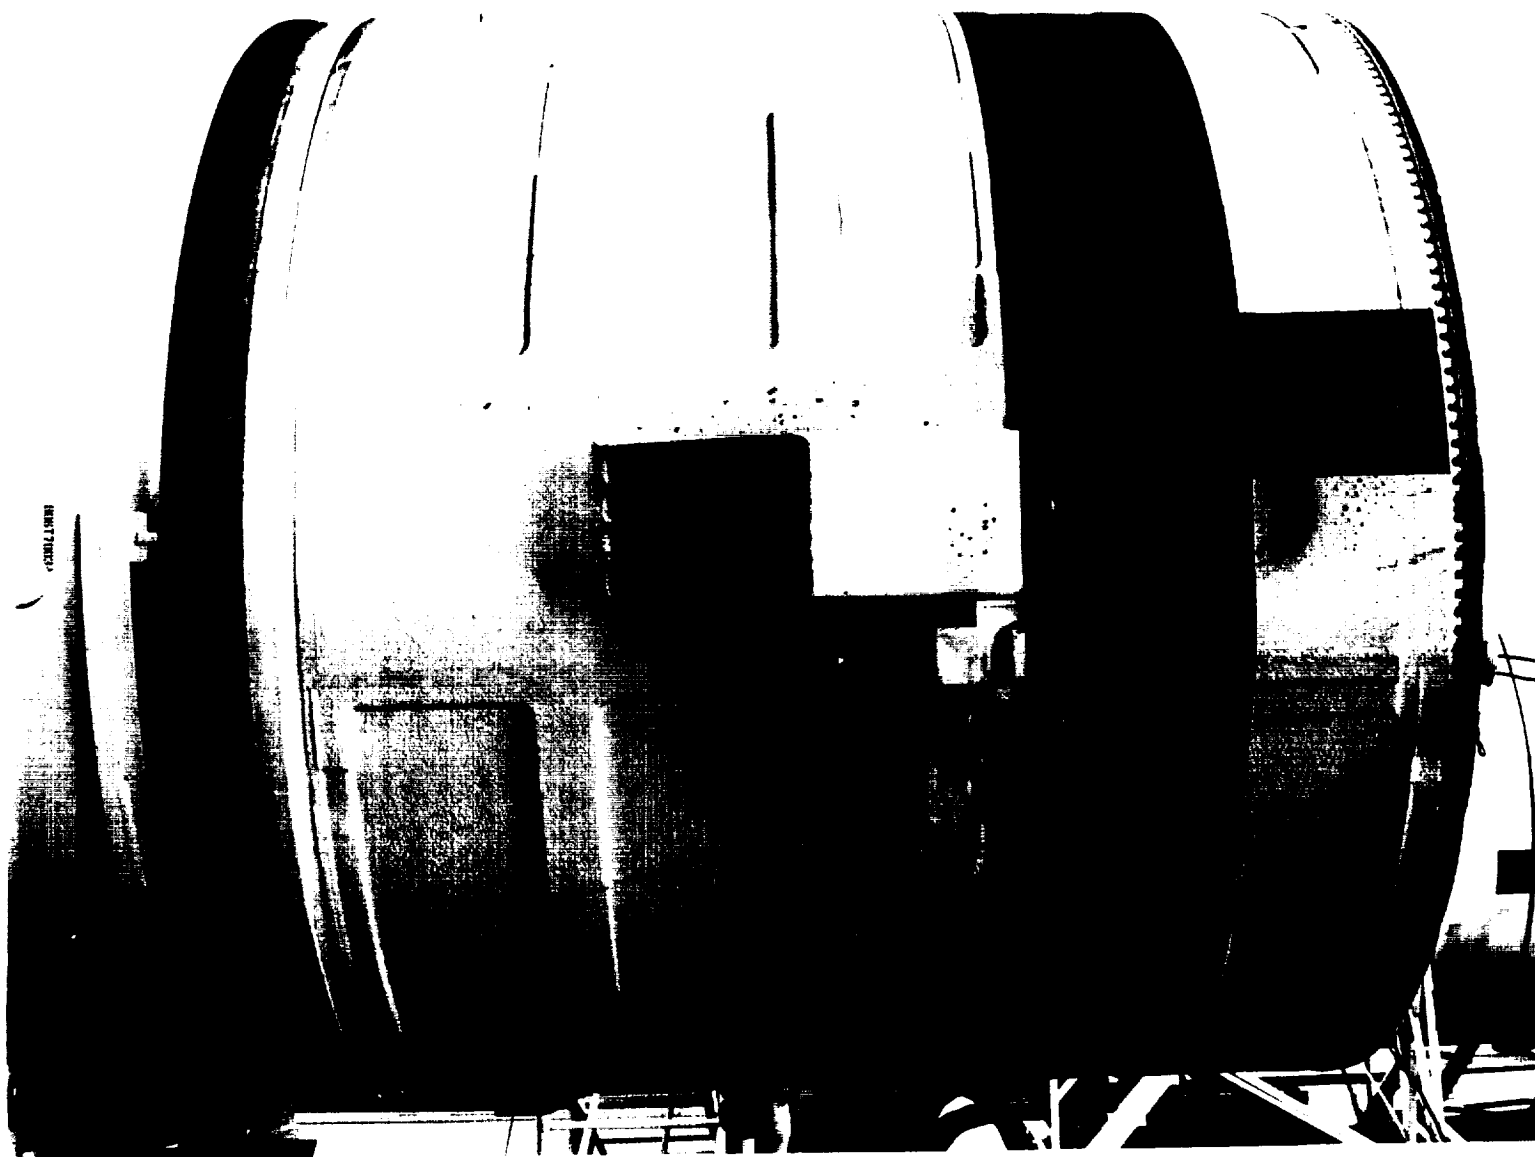
The LH forward skirt exhibited no debonds or missing TPS. The phenolic plates on both RSS antennae were intact. Minor blistering of the Hypalon paint occurred near the ET/SRB forward attach point.

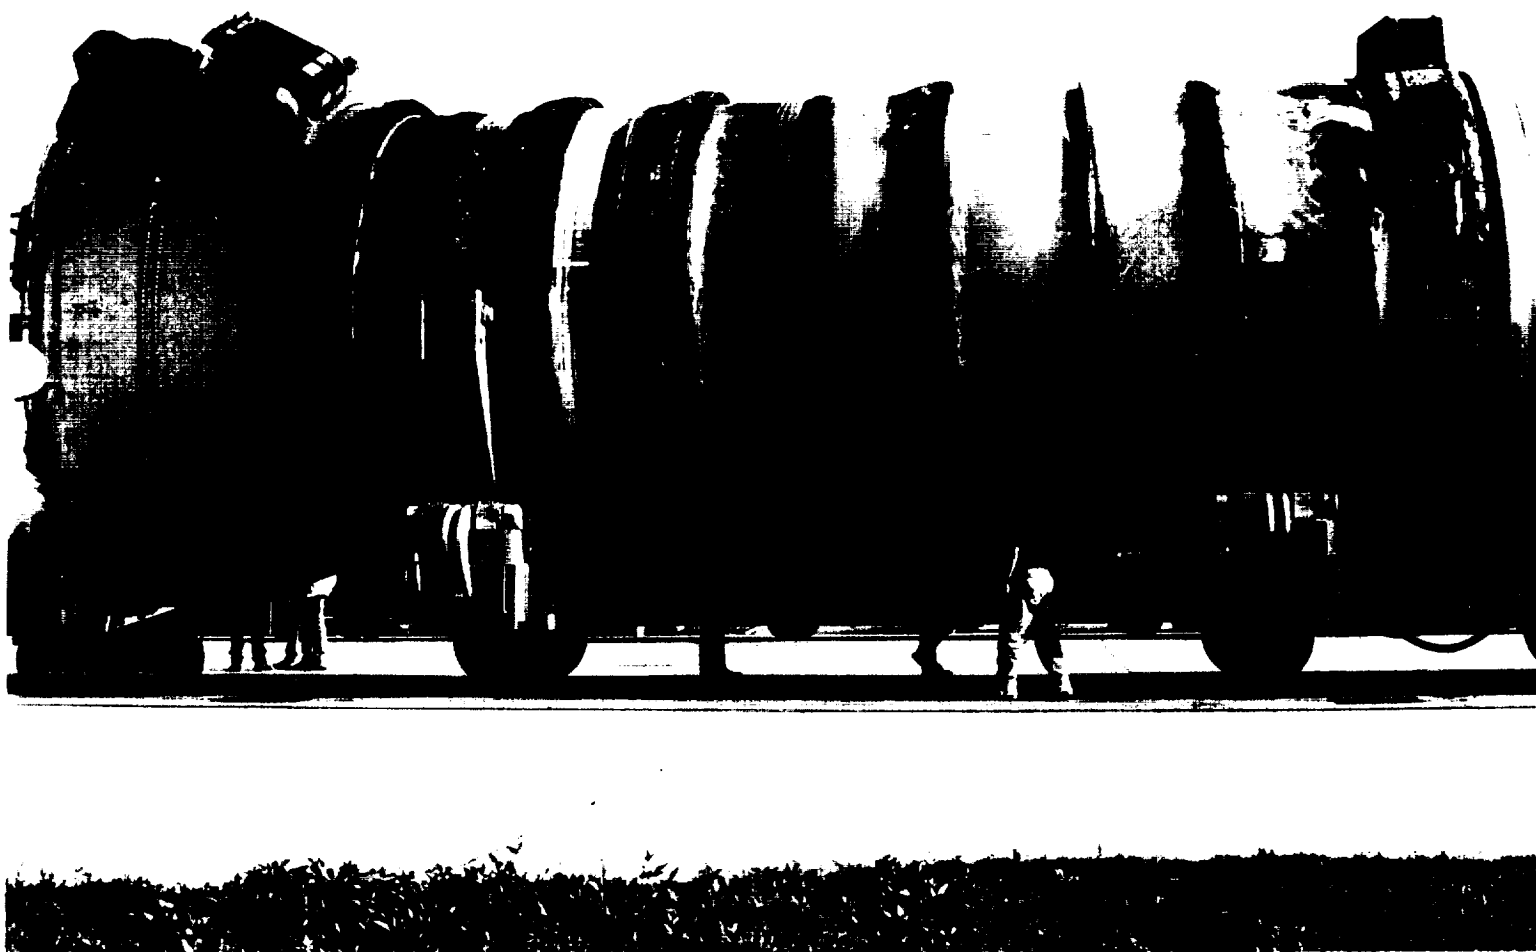
Post flight condition of the aft booster and aft skirt. The ET/SRB aft struts, ETA ring, IEA, and IEA covers appeared undamaged.

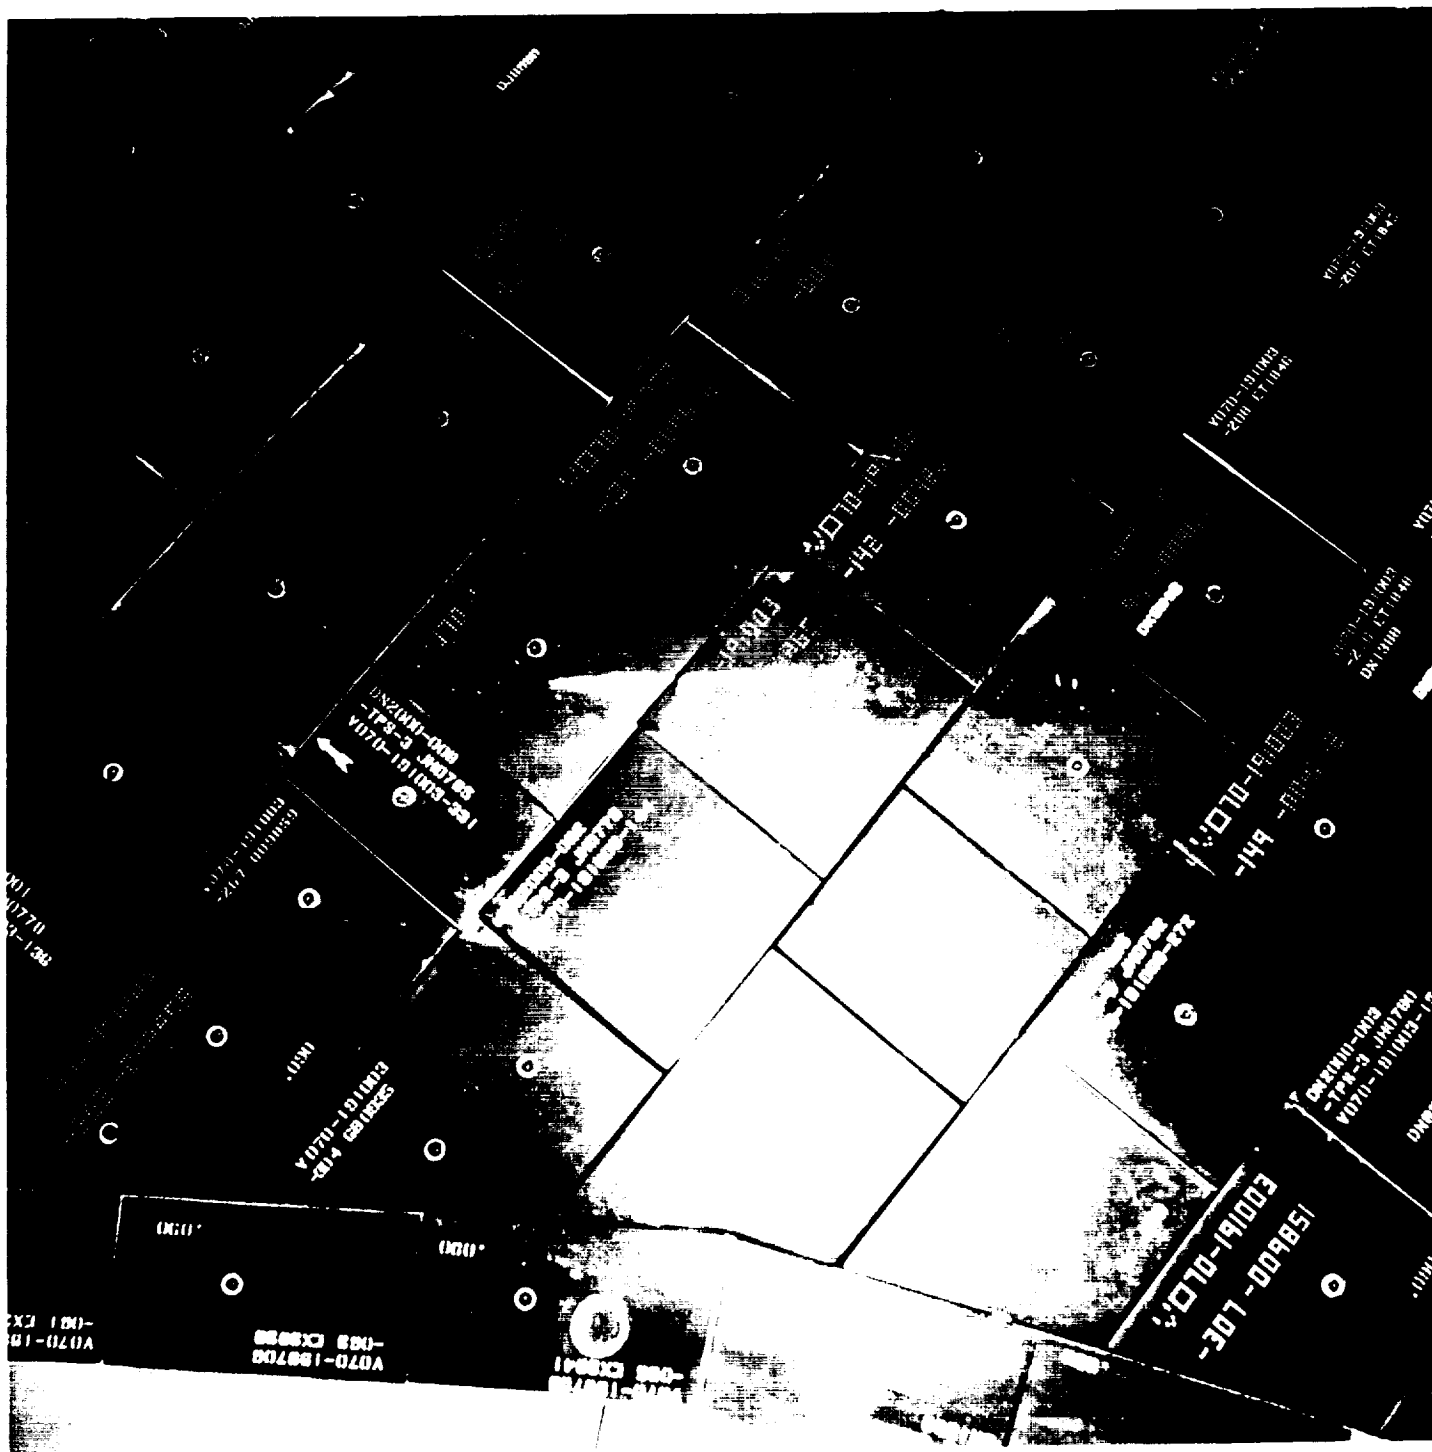
The Orbiter lower surface tiles sustained a total of 80 hits (less than average), of which 14 had a major dimension of 1-inch or greater (average).

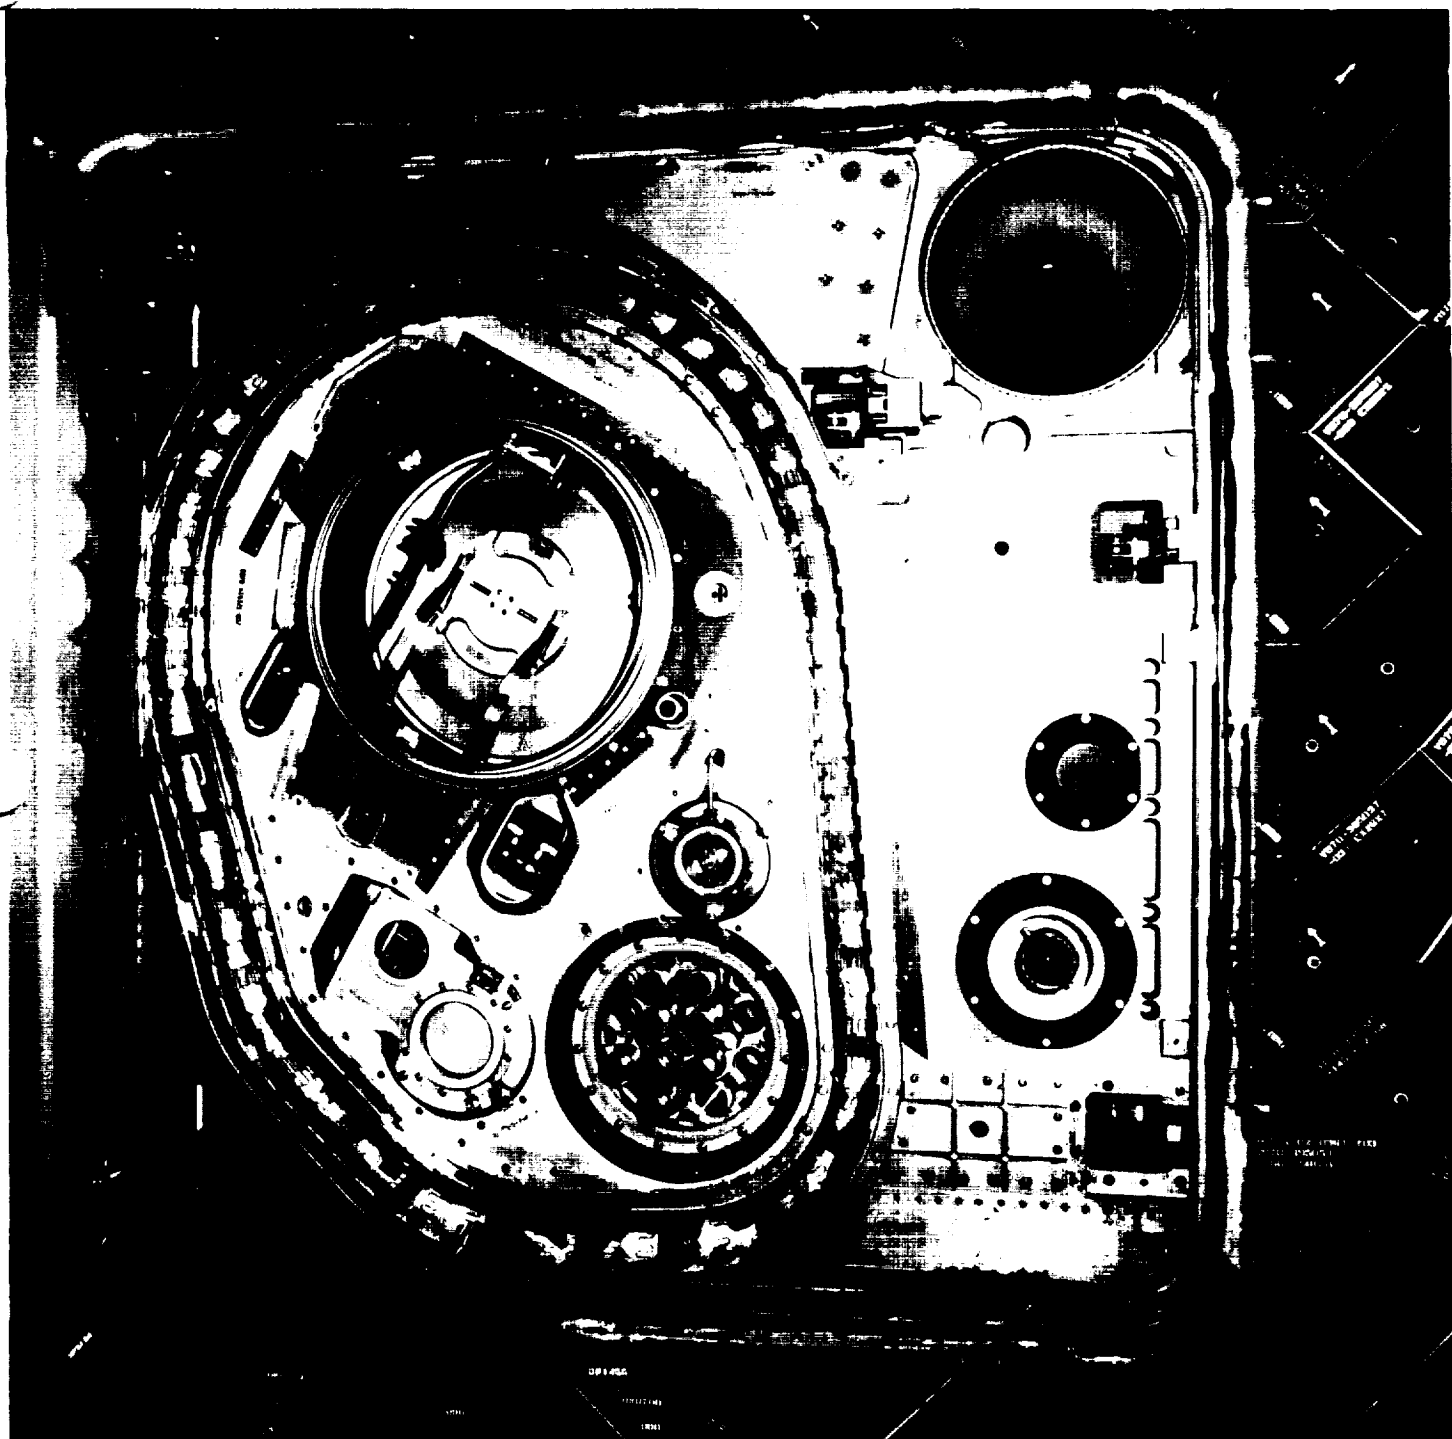
Overall view of the LH2 ET/ORB umbilical. All separation ordnance devices functioned properly. No flight hardware was found on the runway below the umbilical when the ET door was opened.
